**REPORT**  
**ON**  
**SITE SELECTION FOR REHABILITATION OF LANDSLIDE AFFECTED RESIDENCES OF**  
**SILICHONG RURAL MUNICIPALITY AT KHANDBARI MUNICIPALITY, SANKHUWASABHA**  
**DISTRICT,**  
**PROVINCE NO 1**

Government of Nepal  
Ministry of Industry, Commerce and Supplies  
Department of Mines and Geology  
Lainchaur, Kathmandu, Nepal  
2078 (2021)

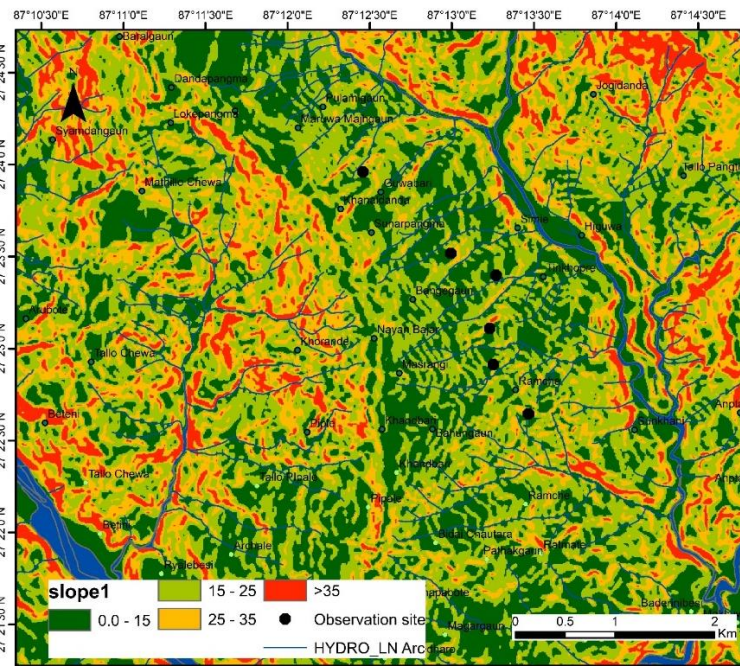
Fig. 3: Slope map of the study and surrounding Area. Black solid circle shows the observation site of this study.

Fig. 3 and Fig. 4 show the Slope and aspect map in and around the observation area respectively. The slope aspect determines the amount of the soil moisture content in different direction or aspect of the hill slope of same region. Slope aspect strongly affects hydrologic processes by the process of the evapo-transpiration and thereby affecting the weathering processes and vegetation root development. The direction of slope faces with respect to the sun has a profound influence on vegetation.

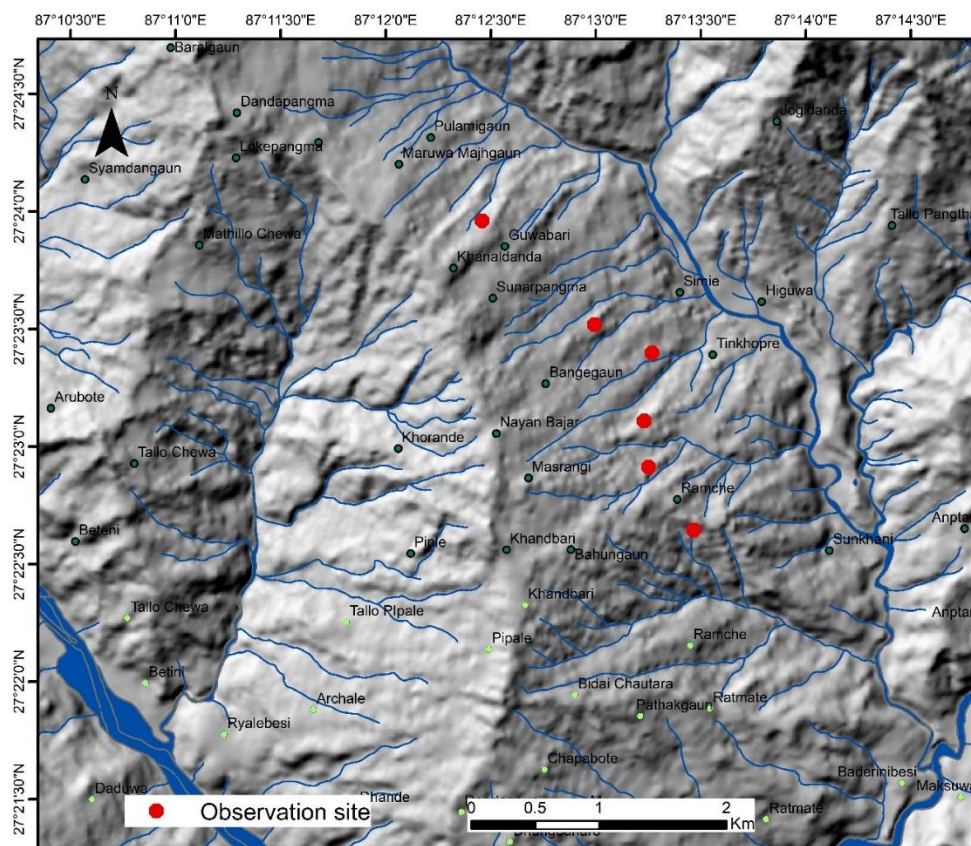
The observation site area lies in mountainous region, North to North-east from office of Khandbari Municipality. The area comprises the steep topography of the Lesser Himalaya. The maximum and minimum elevation around study area is 965 m in observation site-04 and nearly 700 m in the observation site-06. North to Northeast sides of the Khandbari Municipality is drained by numerous streams which all confluences in Panma Khola and ultimately confluences to Arun River. The topography rises abruptly on either side of the river with small tributaries in dendritic drainage fashion, shown in Fig. 5.

Fig. 5: Drainage map of the study and surrounding Area. Red solid circle shows the observation site of this study.

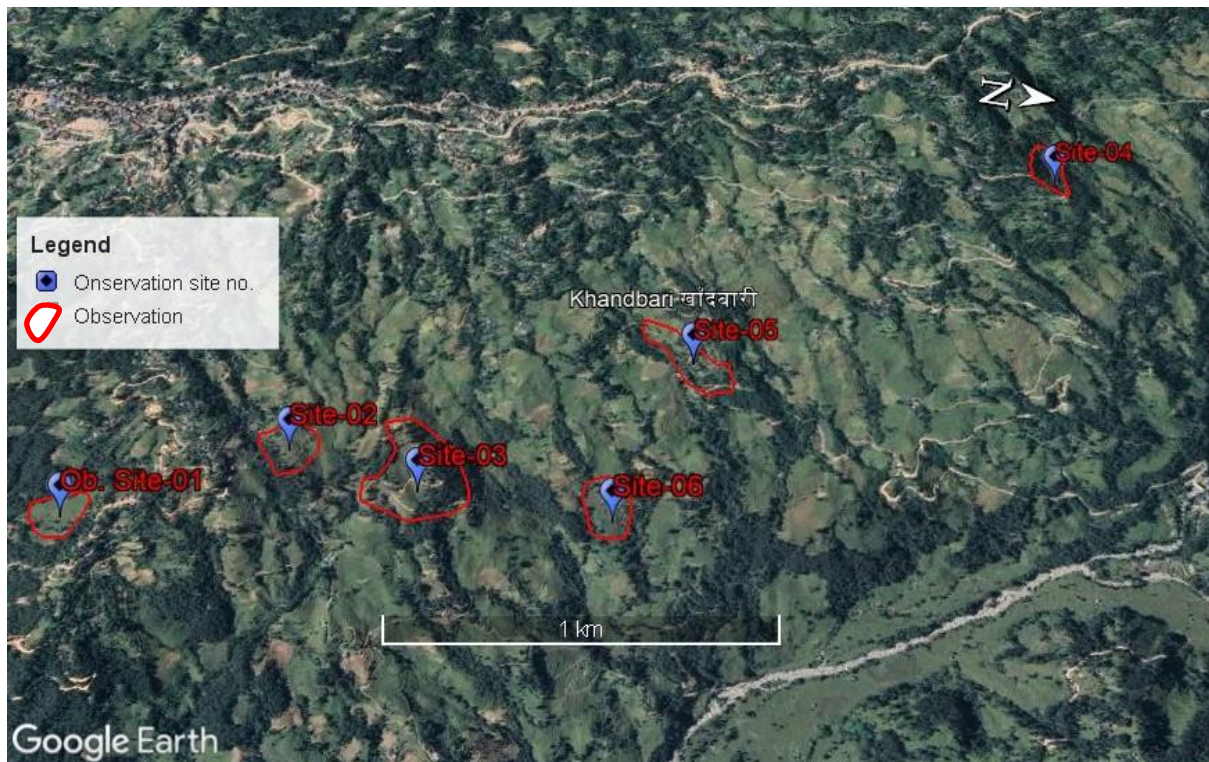
We observed six different site for this purpose, most of these lies north to north-east side of the office of Khandbari Municipality. Fig.6 shows the six different sites in Khandbari Municipality. We focused on rock and soil types, aspect, slope, groundwater conditions, paleo-landslide, and so on. Most of the sites have similar lithology, aspect and slope also. The detailed description through observation site are describe below.

Fig. 6: Google image of all observations site in this study.

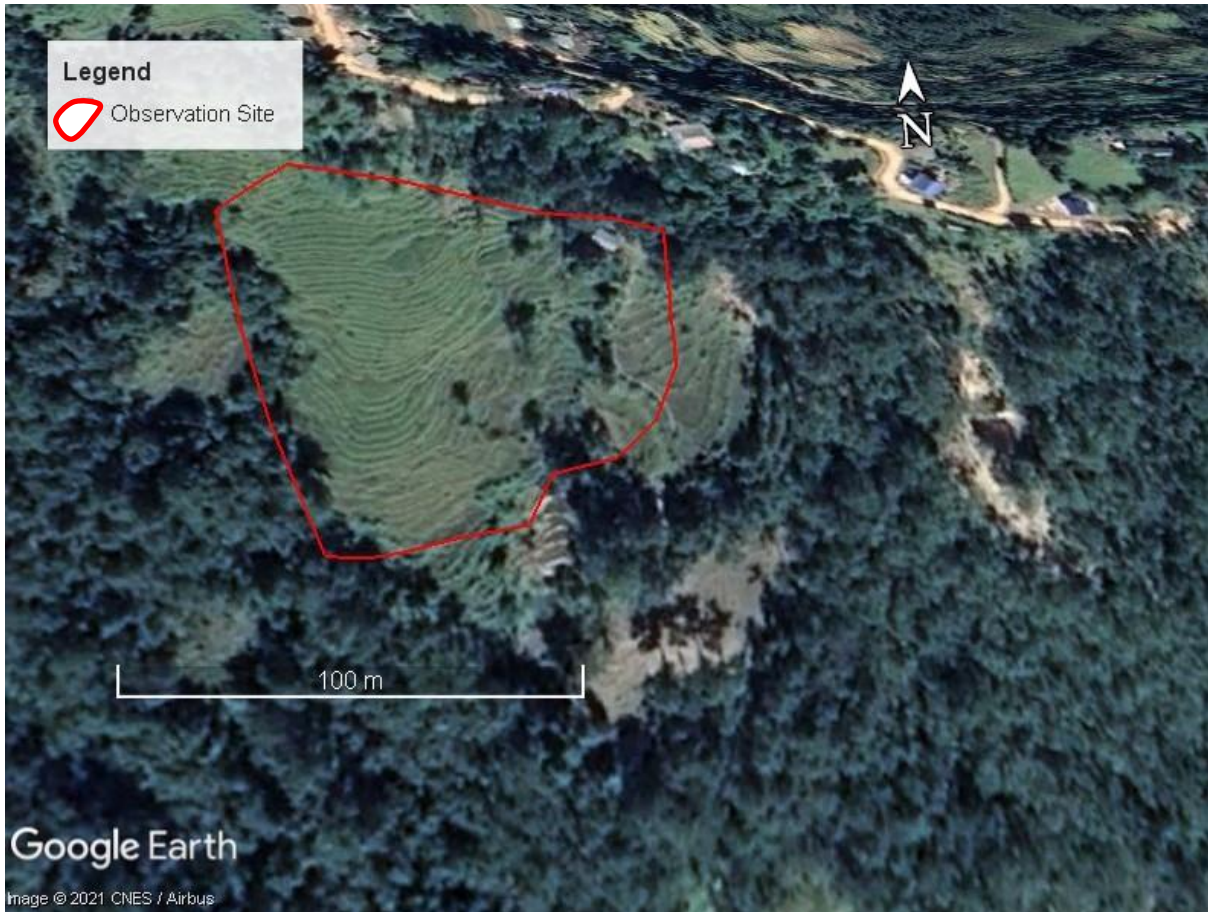
This observation site lies in Khandbari Municipality ward no.7, existing manakamana-01, and eastern side of Municipality's office, around the coordinates 27.37977, 87.22133. It covers around 72.18 Ropani area, but there is few Ropani inside this land. The slope map and aspect map of this area has  $> 25^\circ$  slope angle and east to southeast aspect. This area has a good paddy cultivation, having irrigation water. There is also water spring with well inside this area. This area has wet, having kholsi connected western side of this area. Fig. 7 shows the Google Earth map in and around the observation site-01.

*Fig. 7: Google image of in and around the observation site-01.*

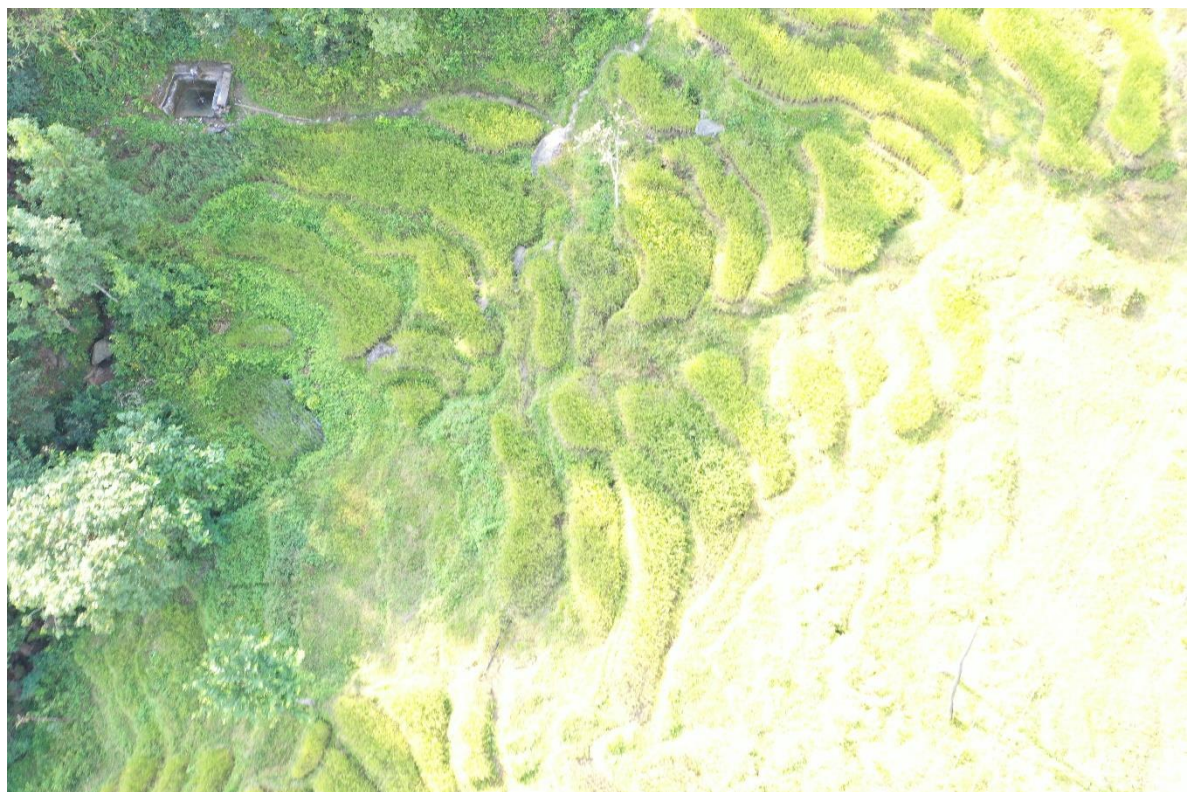
*Fig. 8: Photograph of paddy cultivation with spring well, taken by drone, inside the observation site-01.*

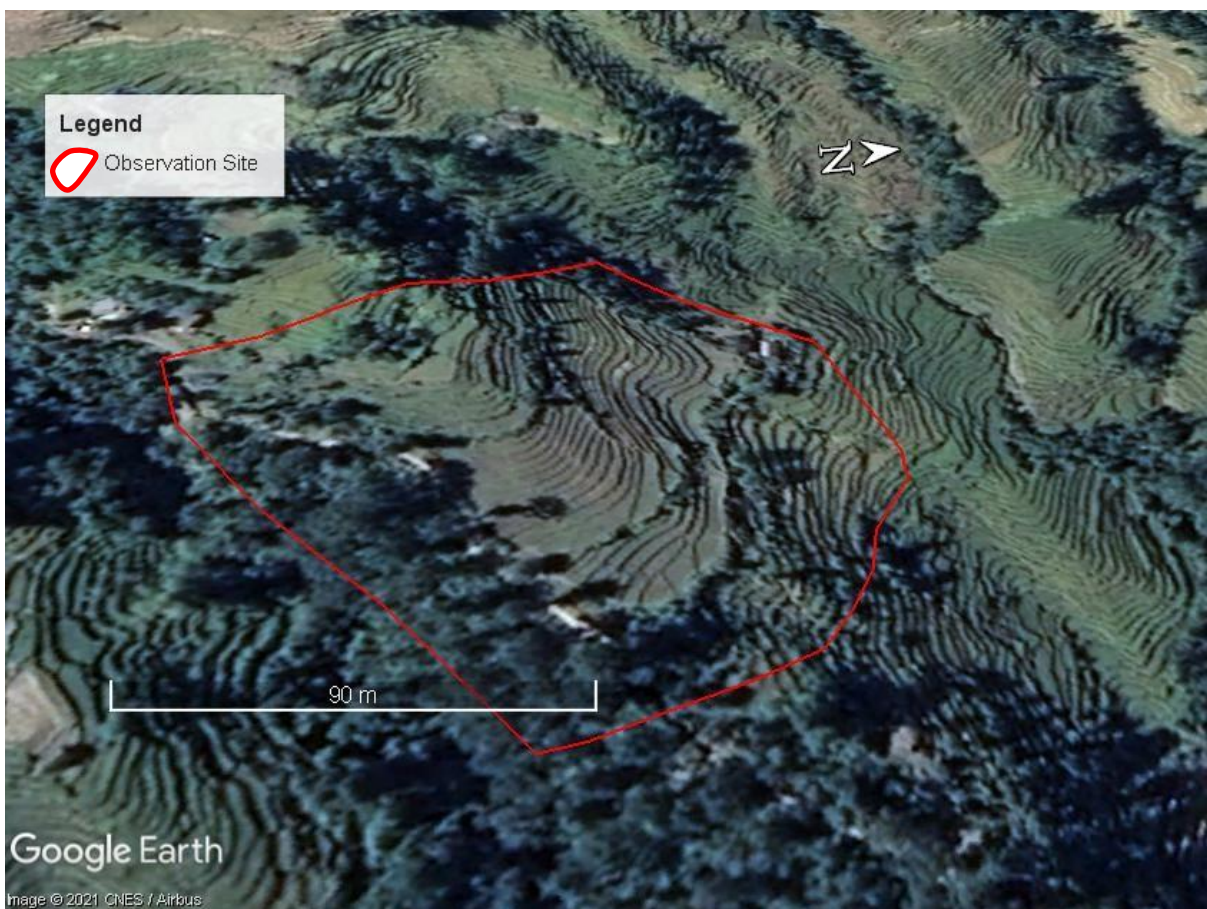
This observation site lies in Khandbari Municipality ward no.7, existing manakamana-01, and northeast side of Municipality's office, around the coordinates 27.38449, 87.218428. It covers around 79.02 Ropani area. The slope map and aspect map of this area has  $> 20^\circ$  slope angle and north to northeast aspect. Most of this area has a good paddy cultivation, having irrigation water. It also contain some forest towards kholsi with high slope and some slides by Kholsi cut. There is also groundwater spring eastern side of this area. This area has wet (besides central part), good for cultivation. Fig. 9 shows the Google Earth map in and around the observation site-02.

Fig. 9: Google image of in and around the observation site-02.

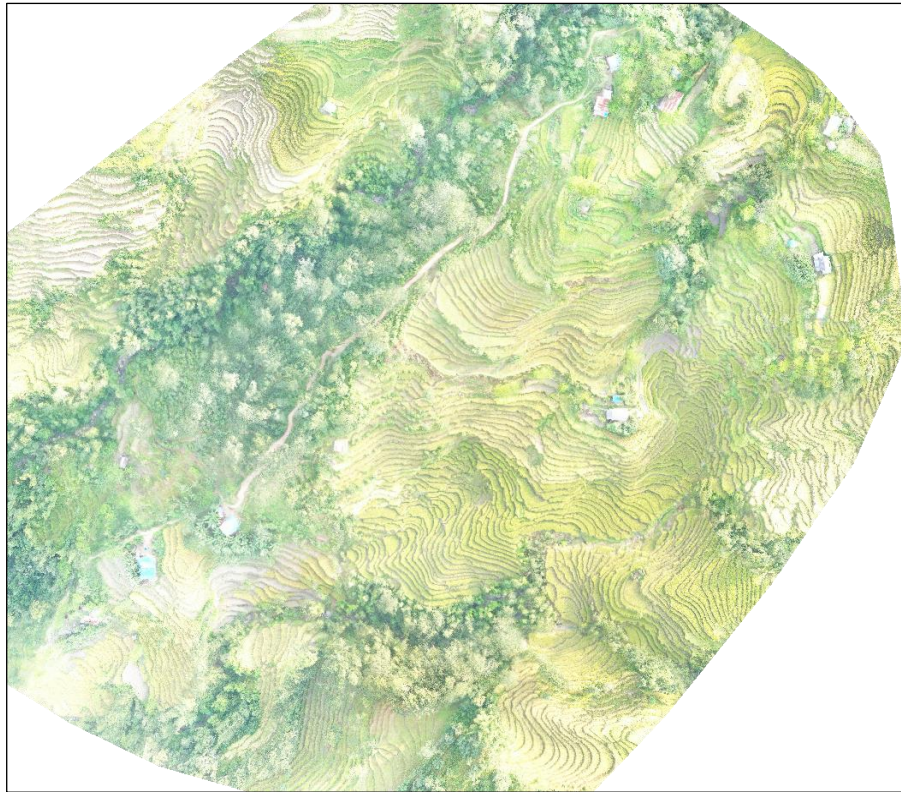
Fig. 10: Ortho-mosaic image of observation site-02, taken from drone (upper) and contour maps (lower) of observation site-02, taken from DSM of drone images.

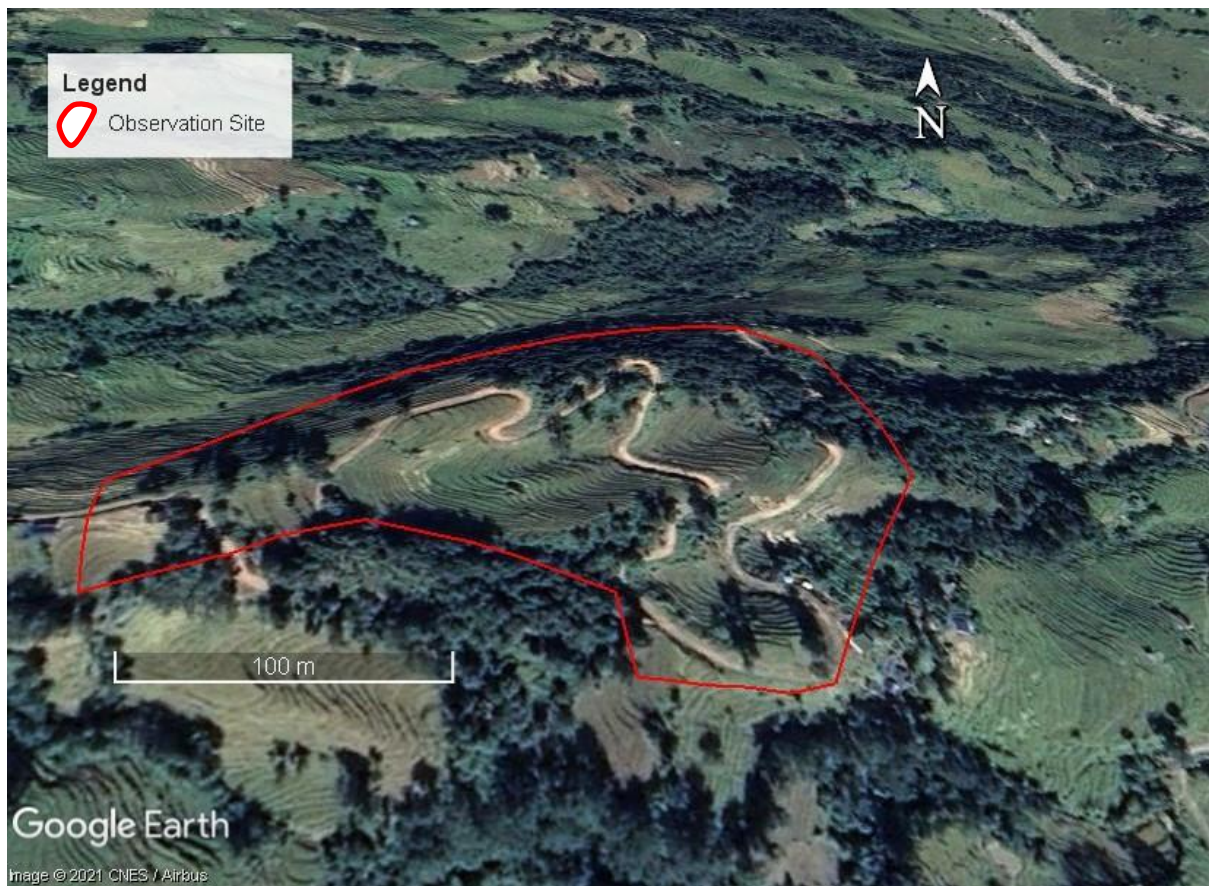
This observation site lies in Khandbari Municipality ward no.7, existing manakamana-01, and northeast side of Municipality's office, around the coordinates 27.3878, 87.2185. It covers around 69.71 Ropani area. The slope map and aspect map of this area has  $> 25^\circ$  slope angle and north to northeast aspect. Most of this area has a paddy cultivation, having less wet than observation site-01 and site-02, having brown to reddish residual soils. It also contain some forest towards northeast part with high slope. Land searching, reconstruction and rehabilitation sub-committee of Sankhuwasabha refers this site as a first priorities, having more than 55 Ropani. We do not find any spring inside of this area. Fig. 11 shows the Google Earth map in and around the observation site-03.

Fig. 11: Google image of in and around the observation site-03.

Location-III contains agricultural land towards the west and forest area towards the east. It is good access to road, electricity and lies at nearest location from the Ward Office and Health Post. Also, the area has no presence of bad-land and erosion is also very less. Springs are located at a short distance. In the lower portion, there is the access to forest also. Bed rock is also exposed at the locality. For agricultural propose, the area is fertile and has chance for being the source of income for the residents. Location 4 contains area that has less than 55 Ropani. The area has access to road but the slope angle is high. So, the area is not suitable for integrated settlement development.

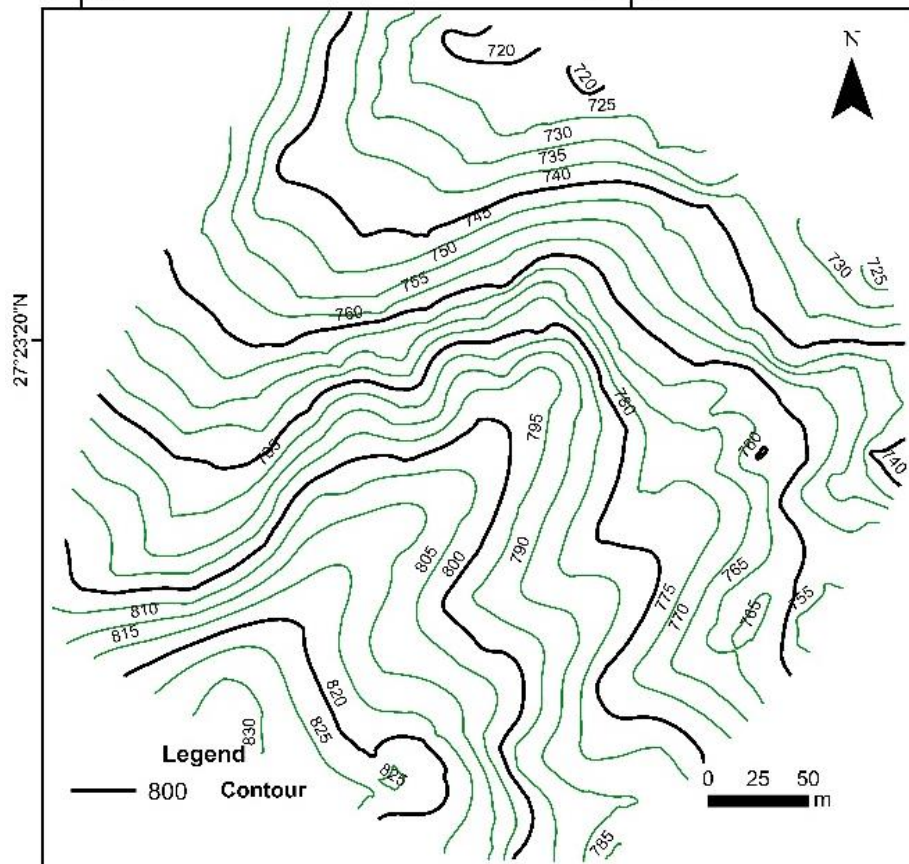
Fig. 12: Ortho-mosaic image of observation site-02, taken from drone (upper) and contour maps (lower) of observation site-02, taken from DSM of drone images.

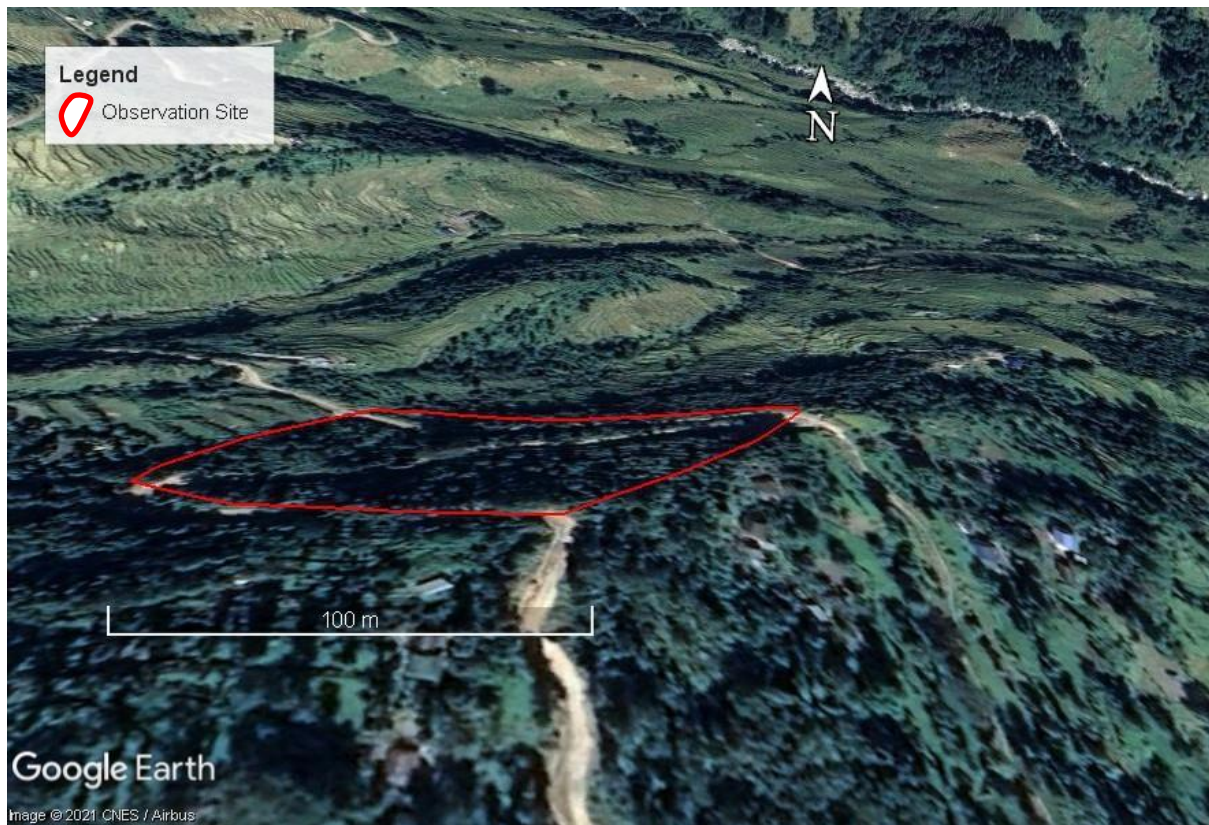
This observation site lies in Khandbari Municipality ward no.3, existing pamma-01, and northeast side of Municipality's office, around the coordinates 27.40239, 87.2055. It covers around 30.54 Ropani area. The slope map and aspect map of this area has  $> 30^\circ$  slope angle and north aspect. Most of the area of this site has forest, having high slope. Bed rocks also exposed in this area. Fig. 13 shows the Google Earth map in and around the observation site-04.

Fig. 13: Google image of in and around the observation site-04.

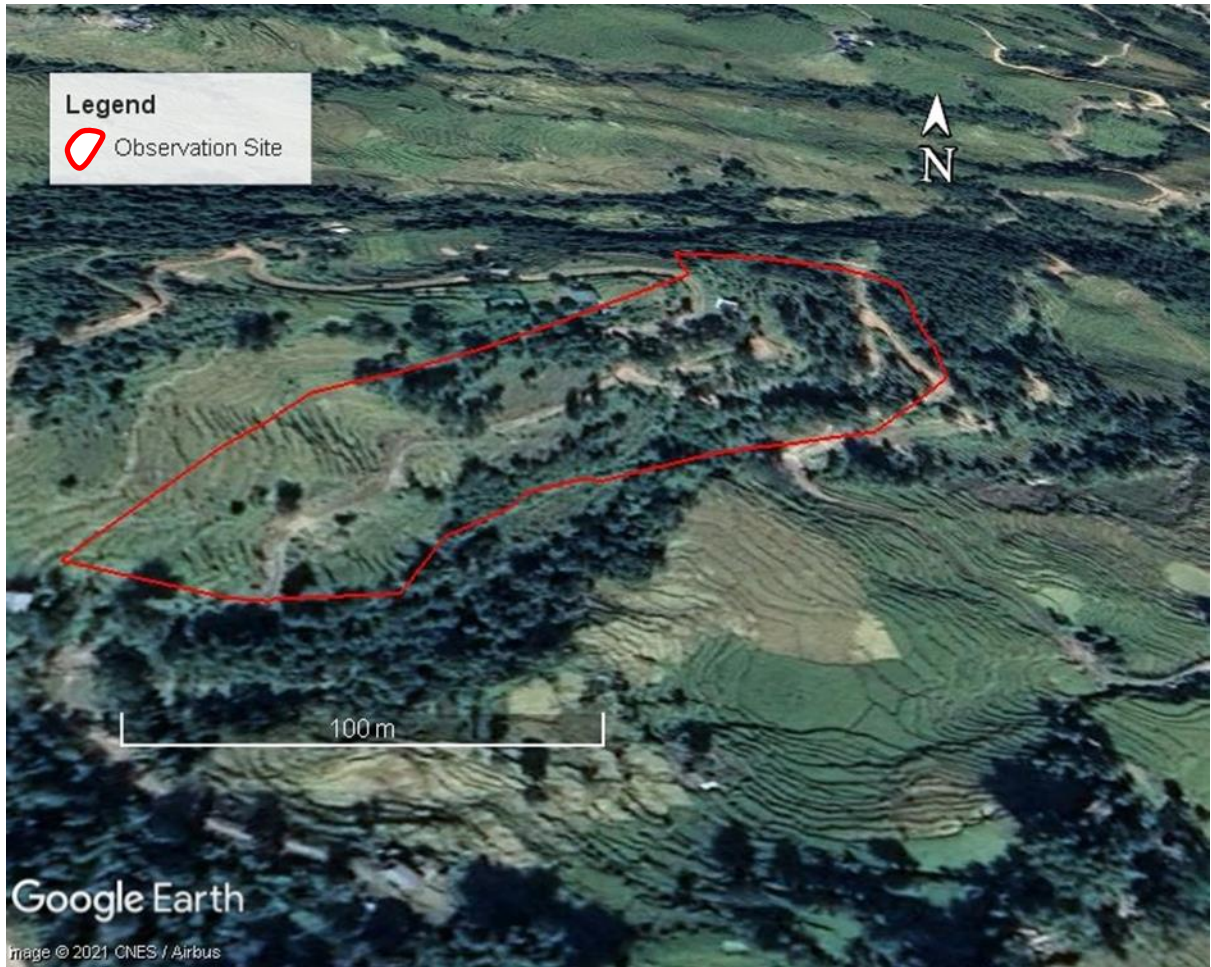
This observation site lies in Khandbari Municipality ward no.7, existing Manakamana-01, and northeast side of Municipality's office, around the coordinates 27.39387, 87.214256. It covers around 45.17 Ropani area. The slope map and aspect map of this area has  $> 25^\circ$  slope angle and north aspect. Most of the area of this site has forest, some has paddy cultivation. Bed rocks also exposed in this area. Fig. 14 shows the Google Earth map in and around the observation site-05.

*Fig. 14: Google image of in and around the observation site-05.*

Location 5 contains the area with rice cultivation, presence of badland and high intensity erosion covered by forests. The area is also possess small scale landslides. Location 6 lies relatively far from the other area. Wet cultivation is practiced. Most of the area faces eastern aspect and experiences sunlight. The slope angle lies from flat land to more than 40<sup>0</sup>. Criteria for integrated settlement were taken in consideration during the report preparation. Existing land-use and infrastructures shows the presence of road in most of the location. No prominent disasters area observed during the field study.

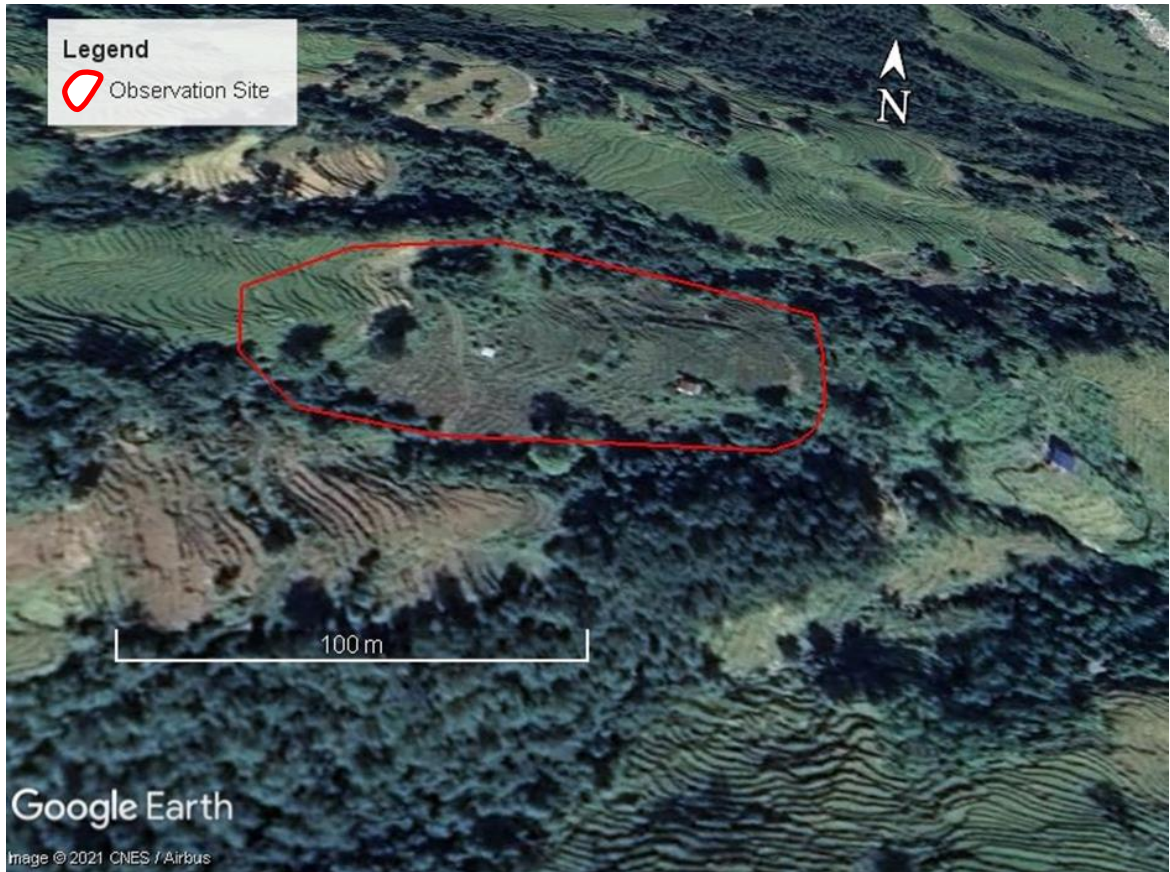
This observation site lies in Khandbari Municipality ward no.7, existing Manakamana-01, and northeast side of Municipality's office, around the coordinates 27.392574, 87.218886. It covers around 47.35 Ropani area. Land searching, reconstruction and rehabilitation sub-committee of Sankhuwasabha refers this site as a first priorities, having less than 55 Ropani. The slope map and aspect map of this area has  $> 20^\circ$  slope angle and north aspect. Most of the area of this site has wet and good for paddy cultivation, having gentle slope. This area is rich in groundwater. Fig. 15 shows the Google Earth map in and around the observation site-06.

*Fig. 15: Google image of in and around the observation site-06.*

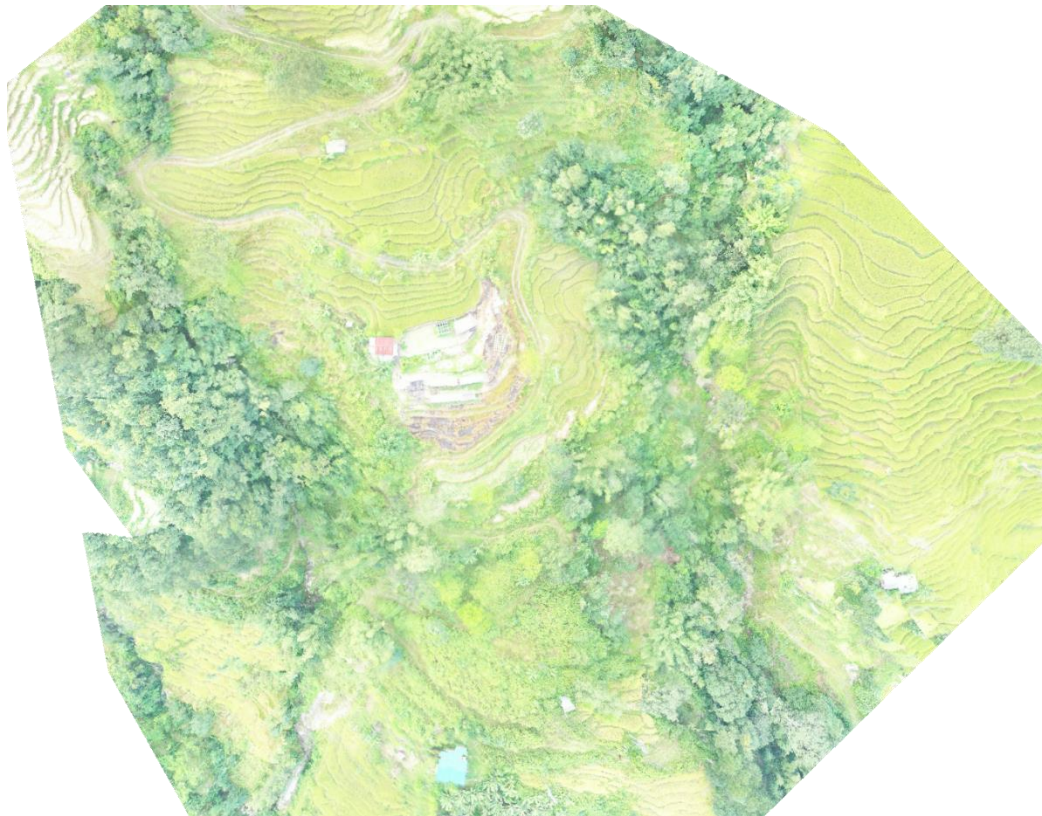
*Fig. 16: Ortho-mosaic image of observation site-06, taken from drone.*
